# REPORT ON FLOOD PROTECTION MEASURES AT THE PUERTO RICO SUN OIL COMPANY YABUCOA, PUERTO RICO

# PREPARED BY METCALF & EDDY DE PUERTO RICO, INC. SAN JUAN, PUERTO RICO

OCTOBER 1990

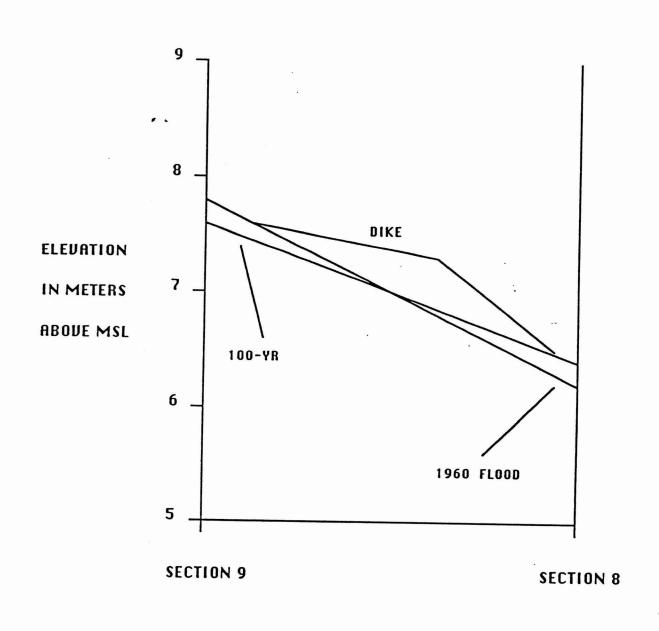
Therefore, using Figure 3 as a basis, and using interpolation to arrive at the revised elevations, Figure 5 was prepared. It shows that, adjusted for the actual bank conditions, the existing levee exceeds the requirements for the 100-year flood event.

- 1. ALL ELEVATIONS WERE ADJUSTED TO REFLECT CONDITIONS ADVACENT TO THE SITE.
- 2. THE FREEBOARD FOR THE 100 YR ELEVATIONS WAS ESTIMATED AT 0.2m.
